PRIMARY RECORD

Page 1 of 2 Resource name(s) or number (assigned by recorder) 40-233 Club View Drive

*c. Address 40-233 Club View Drive

BUILDING, STRUCTURE, AND OBJECT RECORD

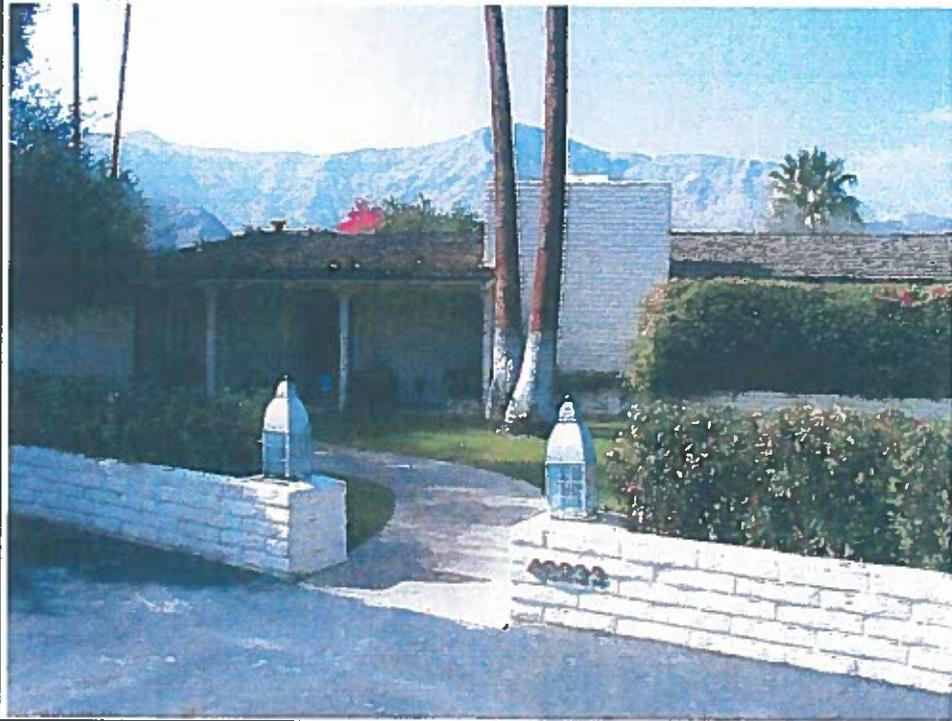
P5a. Photo

This one-story, "L"-shaped Western/Ranch style house was built in 1950 on the ninth fairway of the Thunderbird Country Club golf course. Containing 3,310 square feet with three bedrooms and 4.5 bathrooms, the north-facing residence is topped by a low-pitched, hipped roof of wood shake shingles. Square wood posts with carved brackets support deep overhangs that shade the walkways fronting the house. Exposed rafters are visible beneath the eaves. Exteriors are primarily sheathed in board-and-batten. A wide exterior slumpstone chimney is located west of the main entrance. Dense vegetation obscures the street-facing windows, but the rear elevation has ceiling to floor glazing and sliding glass doors that open to the covered patio and pool area. Posts with carved brackets support a slatted sunscreen over the pool deck. A low slumpstone perimeter wall surrounds the front lawn and borders an asphalt driveway located on the west side of the property. Thick hedges growing from slumpstone planters paralleling the house reach the cornices along the north and west elevations. Rear landscaping consists of a large lawn with two mature olive trees and low shrubs. The house appears original and in excellent condition.

North elevation
November 2002.
