State of California — The Resources Agency
 DEPARTMENT OF PARKS AND RECREATION
PRIMARY RECORD

*c. Address 70-405 Mottle Circle

BUILDING, STRUCTURE, AND OBJECT RECORD

*Resource Name or #: 70-405 Mottle Circle

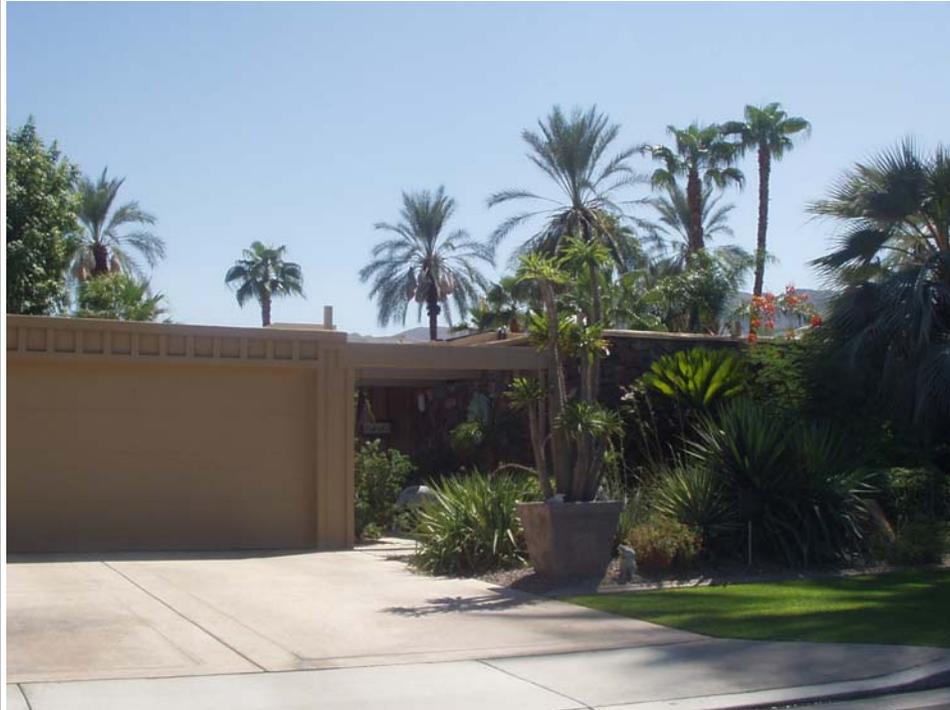
P5a. Photo

Erected in 1963, this one-story dwelling of irregular plan is capped by a flat roof. Board and batten siding and natural rock veneer clad the exterior surfaces of the building's primary (north) elevation. The 2,079 square foot, two bedroom, two and one-half bathroom house is set on a quarter acre lot. A deeply recessed entry porch area is sheltered by several paired overhead beams that continue into the dwelling through clerestory windows. Similar paired beams supporting the living room roof continue past clerestory windows to the covered rear patio and the opposite direction through the natural rock wall facing the street. Thin wood posts support the beam ends where they emerge on the outside of the house. Sliding glass doors fill the spaces between beams and supporting posts that face a sunken landscaped garden and the swimming pool beyond. Rear, pool-facing elevations feature pecky cypress paneling in contrast with the rock and board and batten primary façade. A large double-car garage framed by board and batten siding is located east of the recessed entry area. A concrete path leading to the entry porch bisects a grassy lawn that is flanked by palm trees and mature desert landscaping. Evidence indicates that the garage has been modified, but the remainder of the dwelling appears mostly original and is in excellent condition.

P5b. Description of Photo: (view and date)

North elevation
 August 2008
