State of California — The Resources Agency
 DEPARTMENT OF PARKS AND RECREATION
PRIMARY RECORD

Page 1 of 1 Resource name(s) or number (assigned by recorder) *Halper Residence*

*c. Address *36-927 Palm View Drive*

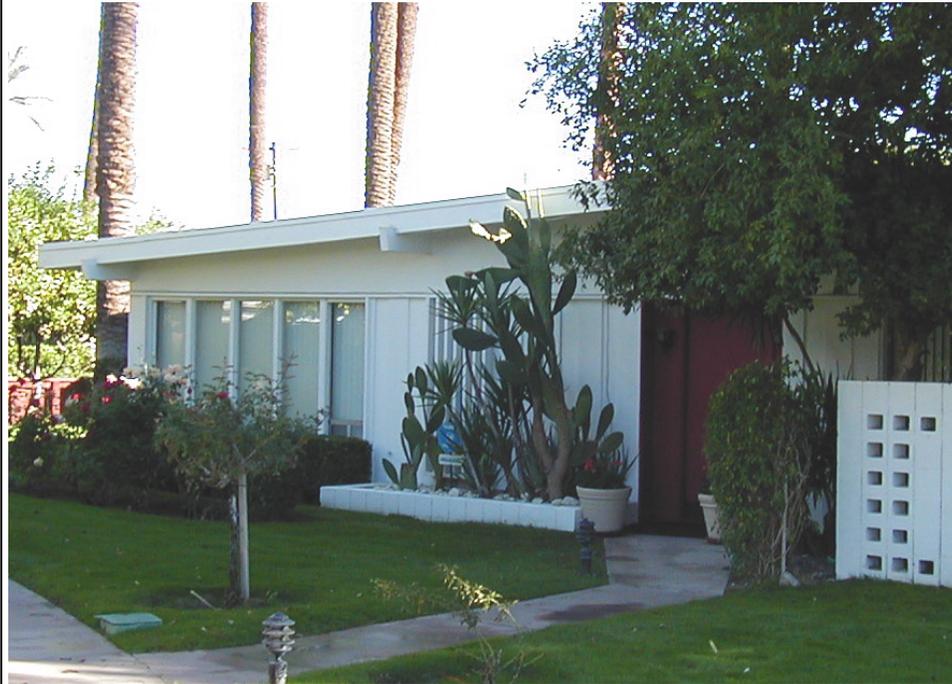
P5a. Photo

This property is one of the Tamarisk Ranchos cluster of 16 single-family residences, designed by the in-house architects for developer Lou Halper's Devon Construction Company in 1958. Although each one-story house is free-standing, they share a cooperatively-owned central park and swimming pool area towards which all of the residence's rear elevations face. The cluster is located one block east of the Tamarisk Country Club golf course. This is the house originally owned by Tamarisk Ranchos developer Lou Halper. The Halper Residence has a low-pitched front gabled roof covering 1,901 interior square feet with three bedrooms and 2.5 bathrooms. Exteriors are sheathed in board-and-batten and medium-smooth stucco. Exposed roof beams project beneath deep eaves that shade most elevations. A decorative concrete block screen is below the gable peak, enclosing a small patio. Windows are fixed and narrow north of the rear entrance with sliding glass doors to the south. The meticulously maintained park-like grounds include vast lawns, trimmed hedges, and a virtual grove of mature date palms. The house is original and in excellent condition. The property would contribute to a potential historic district that could be designated under an existing or proposed local ordinance (a "5D1" National Register Status Code).

P5b. Description of Photo: (view and date)
*West elevation
 November 2002*
