State of California — The Resources Agency
DEPARTMENT OF PARKS AND RECREATION
PRIMARY RECORD

Resource name(s) or number (assigned by recorder) *Dillman Residence*

*c. Address *40-780 Thunderbird Road*

City *Rancho Mirage*

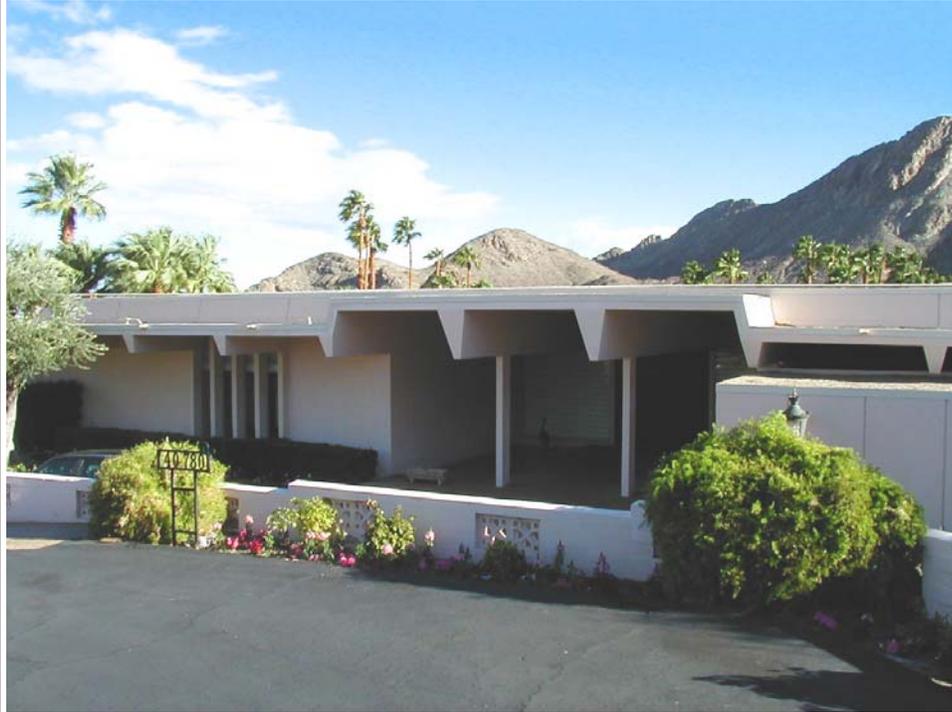
P5a. Photo

Finnish architect C. Barlund drew the plans for this one-story, flat-roofed residence in 1964, although the building was not constructed until 1967. The "L"-shaped house located in Thunderbird Heights is 3,332 square feet, with three bedrooms and 2.5 bathrooms, and is set on .49 acres. Medium-smooth stucco sheathes the exteriors. "V"-shaped beams beneath deep overhangs are the strongest visual element of the house. A pair of wood posts supports the roof of the deeply recessed center entrance porch. Shallow rectangular ponds faced with blue tiles flank the porch walkway. The double carved wood entrance doors have floor to ceiling plate glass sidelights. A row of four narrow vertical fixed windows is located north of the porch. South of the porch is a projecting storage area and enclosed double car garage. Rear elevations are primarily floor-to-ceiling walls of glass. Aluminum-framed sliding glass doors open to the swimming pool area. The rear patio, steps, and pool deck are coated with a brown pebble-like material. Lawns, clipped hedges, flowerbeds, and mature trees surround the property. A circular driveway, also paved with pebble-like material, dips down below street level past the entrance. The house appears mostly original and in excellent condition.

P5b. Description of Photo: (view and date)
*Northwest elevation
November 2002*

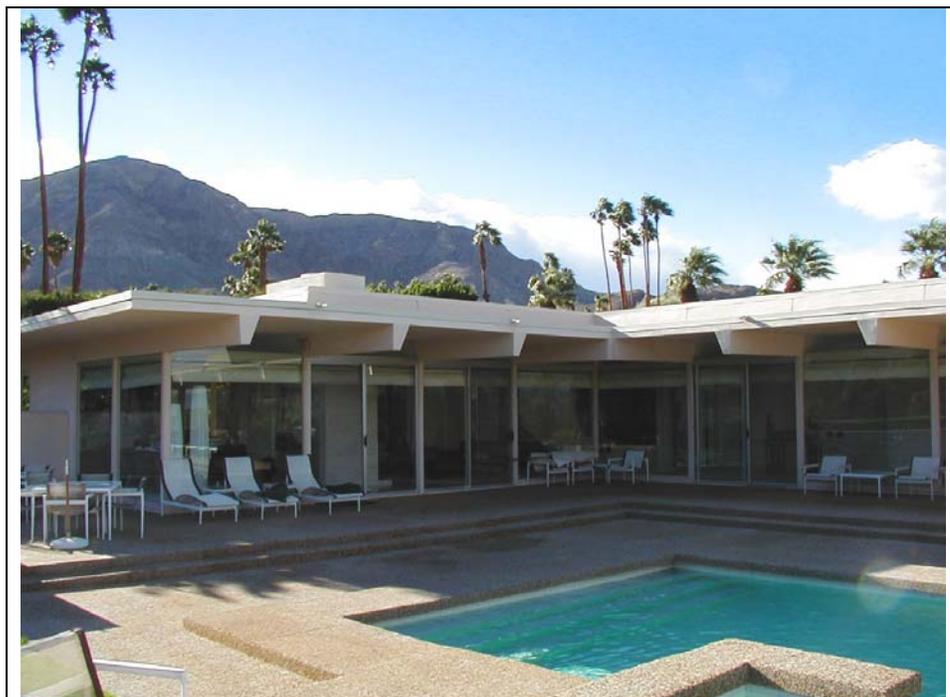
P5b. Description/Date of Photo: *View of pool area looking southwest at southeast and northeast elevations, November 2002.*
